DOT/FAA/RD-92/8

Performance of Insulated Pavements at Newton Field, Jackman, Maine

Maureen A. Kestler
Richard L. Berg

May 1992

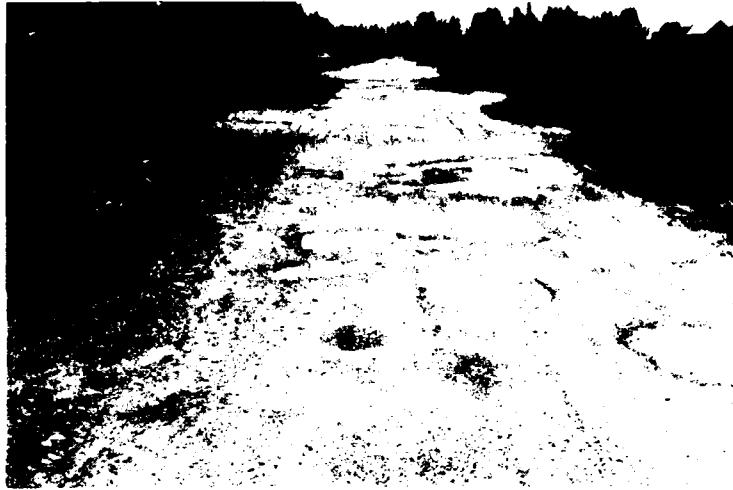
Figure 2. The Newton Field runway before 1986.

The runway at Newton Field was reconstructed in 1986. The old runway was in extremely poor condition, as is shown in Figure 2. The longitudinal and transverse pavement surface was highly irregular and was disintegrating as a result of moisture entering the large number of cracks. Although located in the same vicinity as the old runway, the new 2900- × 60-ft runway is longer, wider, and at a slightly different orientation than the old runway.

a. Looking northwest.

b. Boulder heave.

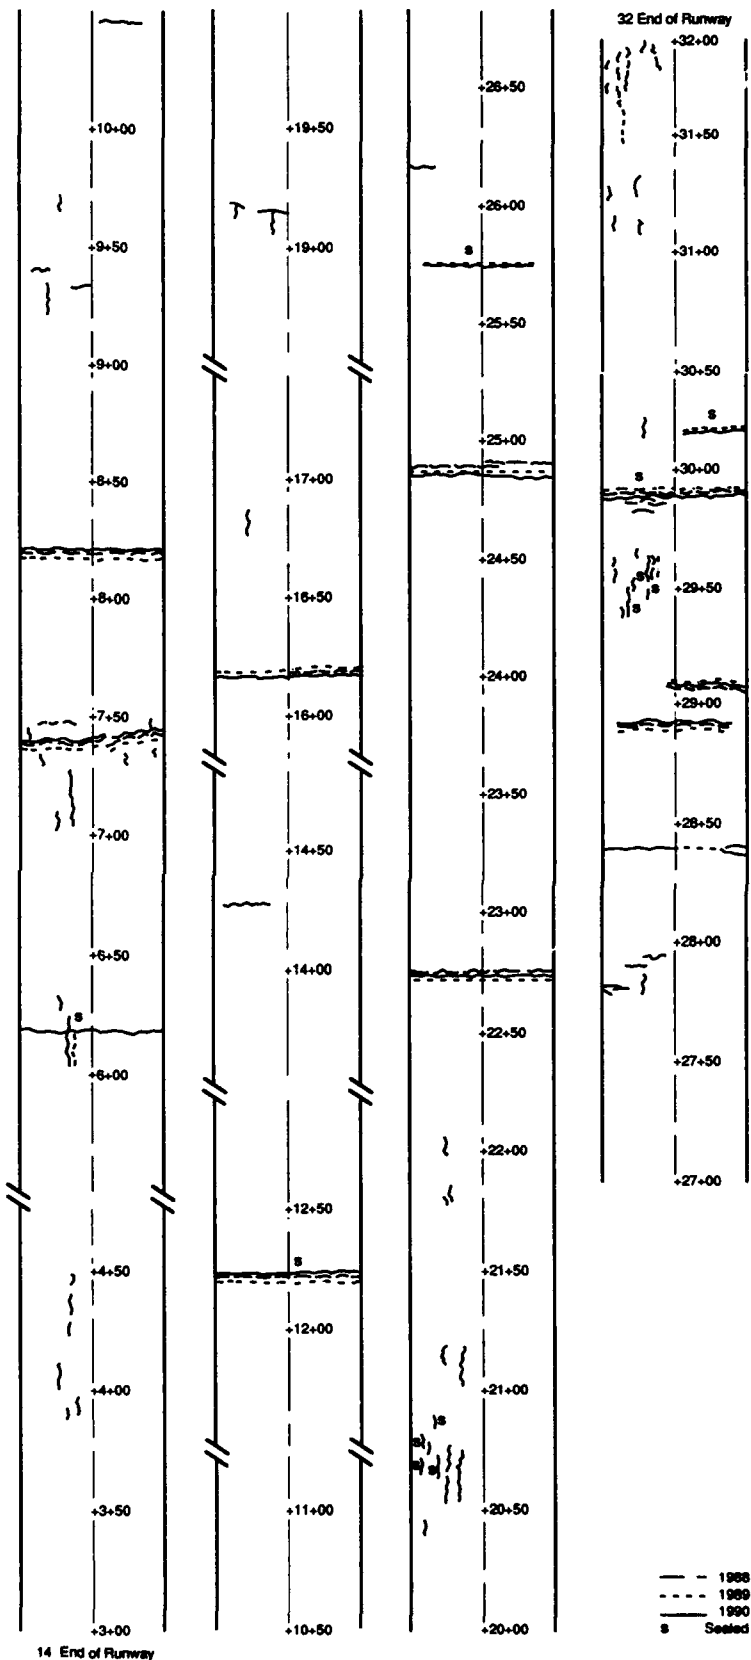
Figure 9. Newton Field pavement crack map.

The progression of crack development following placement of the final 1 1/4-in. asphalt concrete lift in 1987 is shown in Figure 9. Although the cracks had been sealed in September 1989 with a rubberized crack sealer and polyfiber, nearly all cracks have since reopened. In all instances, the failure occurred due to a loss of adhesion between the asphalt pavement and the sealing agent. The crack shown in Figure 10a was unsuccessfully sealed with silicone shortly before being resealed with the rubberized crack sealer.

Generally, the cracks have manifested themselves in two varieties: small longitudinal cracks typically occurring in localized groups, and individual long, wide, transverse cracks. Elev-

en transverse cracks extend across, or nearly across, the entire runway, and two transverse cracks extend across the taxiway. Crack density is particularly high at the southeast (32) end of the runway; elsewhere, cracks are fairly evenly distributed.

The asphalt concrete is beginning to exhibit signs of secondary cracking. One possibility is that the base course has eroded from beneath some of the larger cracks; however, no evidence of removed material has been observed at the edges of the runway. Figure 10b illustrates a crack at least 9 in. deep at station 16+15, and Figure 10c shows the results of the secondary cracking and ensuing settlement of approximately 3 in. at station 29+95. While Figures 10b and c represent the most extreme of the crack-related failures exhibited by the four-year-old pavement, progressive deterioration is inevitable unless the cracks are successfully sealed.

2. Extreme pavement distress is exhibited by cracks up to 9 in. deep and by severe secondary cracking. It is recommended that both the pavement surface and the underlying insulation be monitored for horizontal displacement. From this it could be determined whether the extreme crack-related failures are due to differential movement caused by the extreme temperature fluctuations experienced by insulated pavements, movement of the asphalt concrete and frozen base, or shrinkage of the asphalt concrete due to accelerated aging.

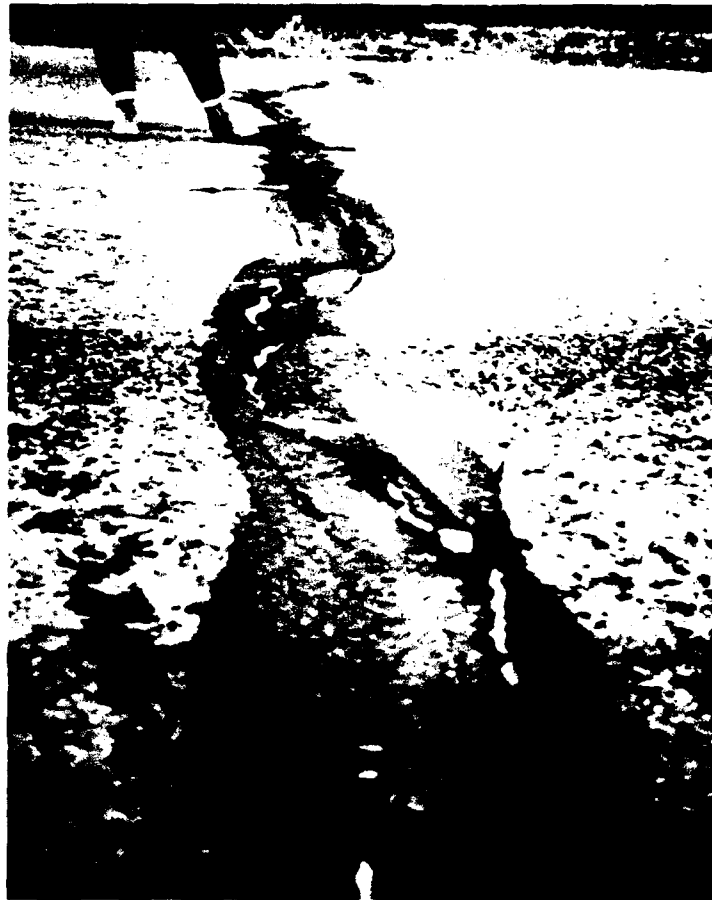
a. Crack at station 8+22 initially sealed with silicone, then with a rubberized crack sealer.

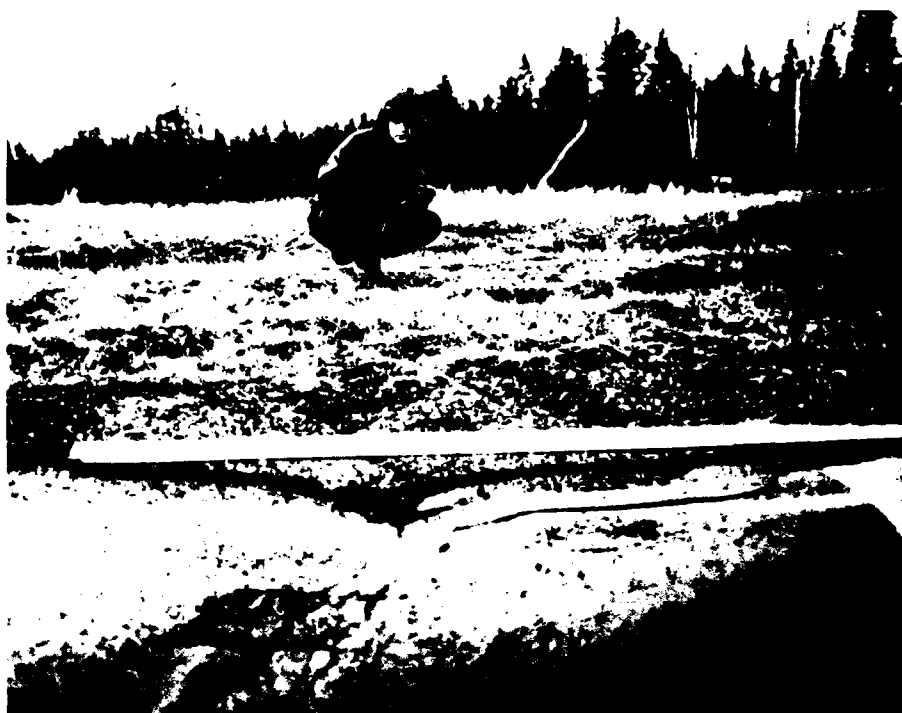
c. Settlement of pavement at station 29+95

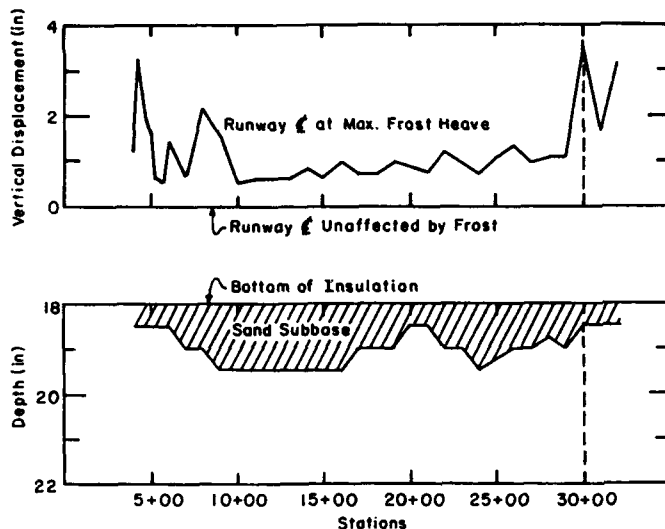
Figure 11. Profile of frost-heaved centerline and corresponding depth of sand subbase, March 1990.

32+00, approximately 3 in. Figure 11 shows both the March 1990 centerline profile and the depth of sand subbase along the length of the runway. The areas that experienced appreciable frost heave generally correspond to the two ends of the runway that were excavated to a lesser depth. In addition, both ends of the runway were particularly spongy during construction.
